NASA CR-66840

METEOROID PENETRATION DETECTOR DEVELOPMENT PROGRAM

FINAL SUMMARY REPORT  
VOLUME I

Prepared under Contract No. NAS1-7043 by  
MARTIN MARIETTA CORPORATION  
Denver, Colorado

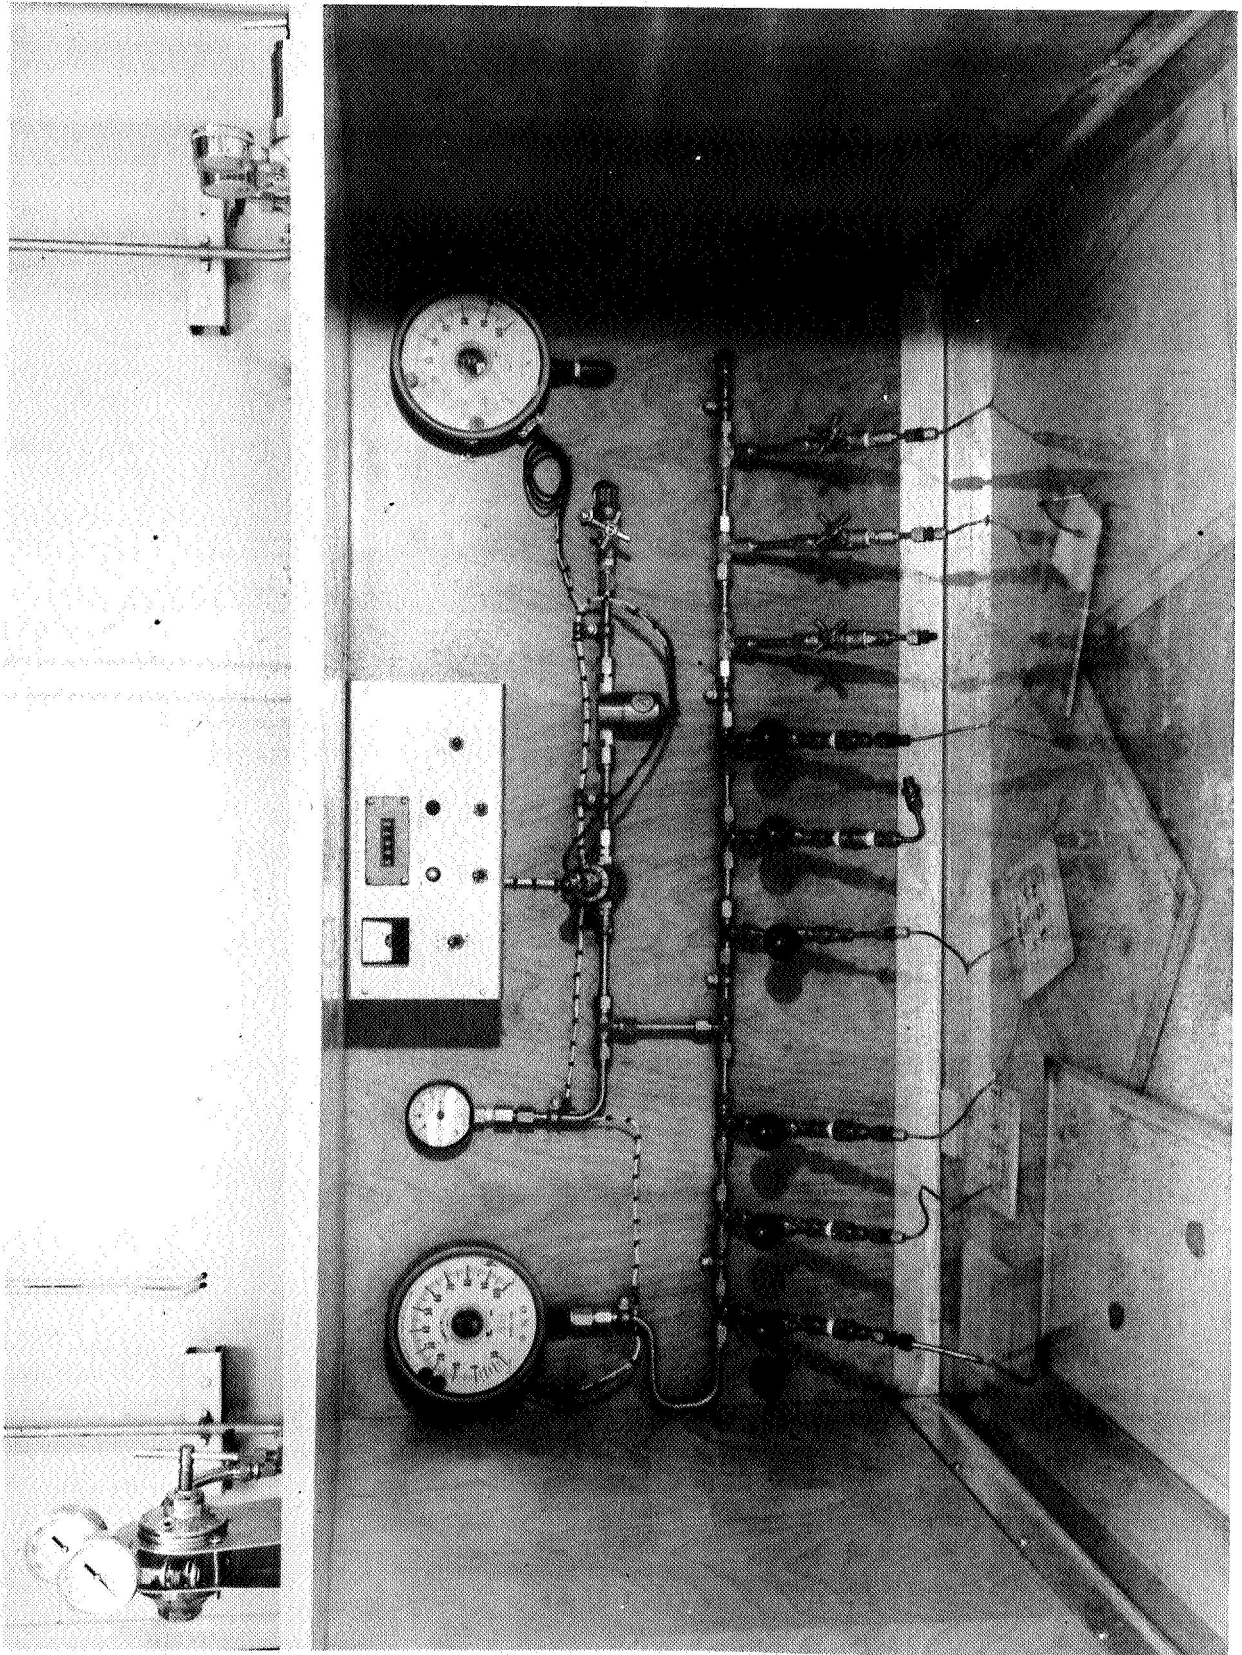
Figure 83.- Pressure Cycling Tool

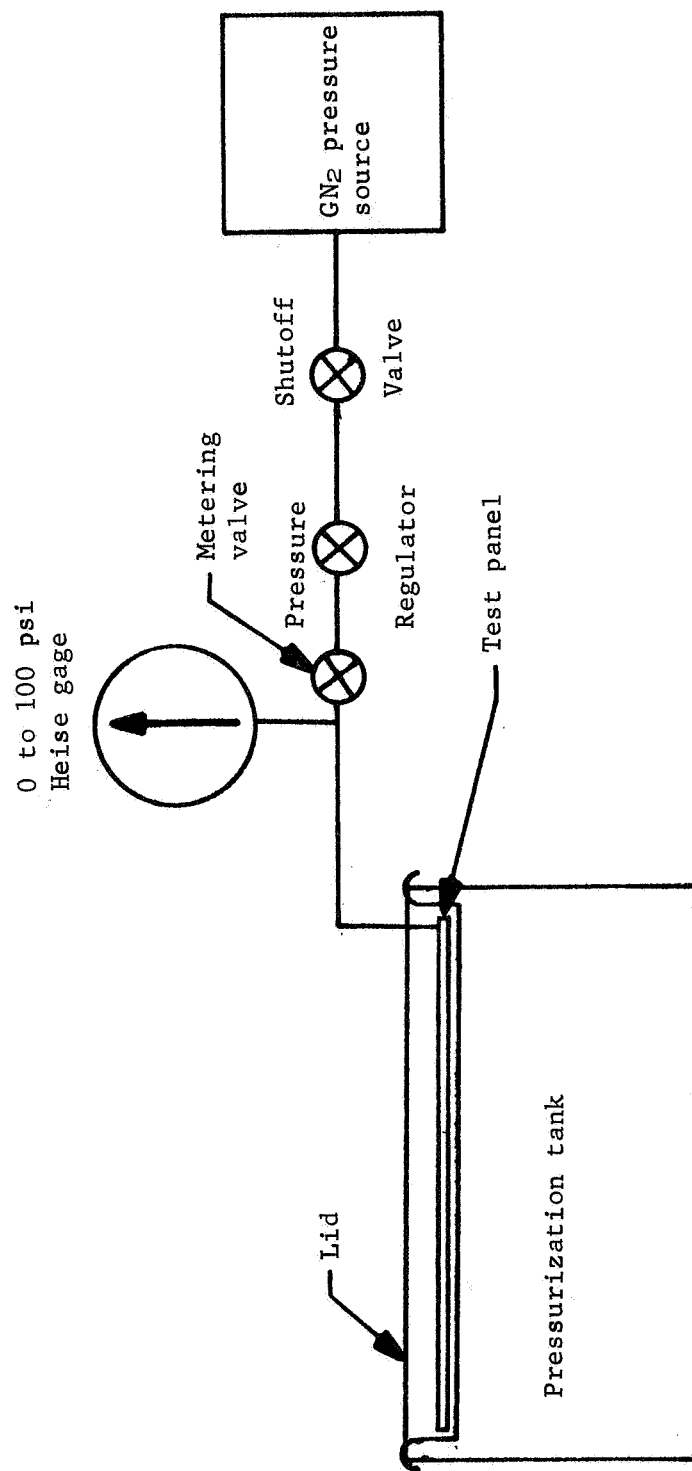
Figure 86.- Proof Pressure Test Setup

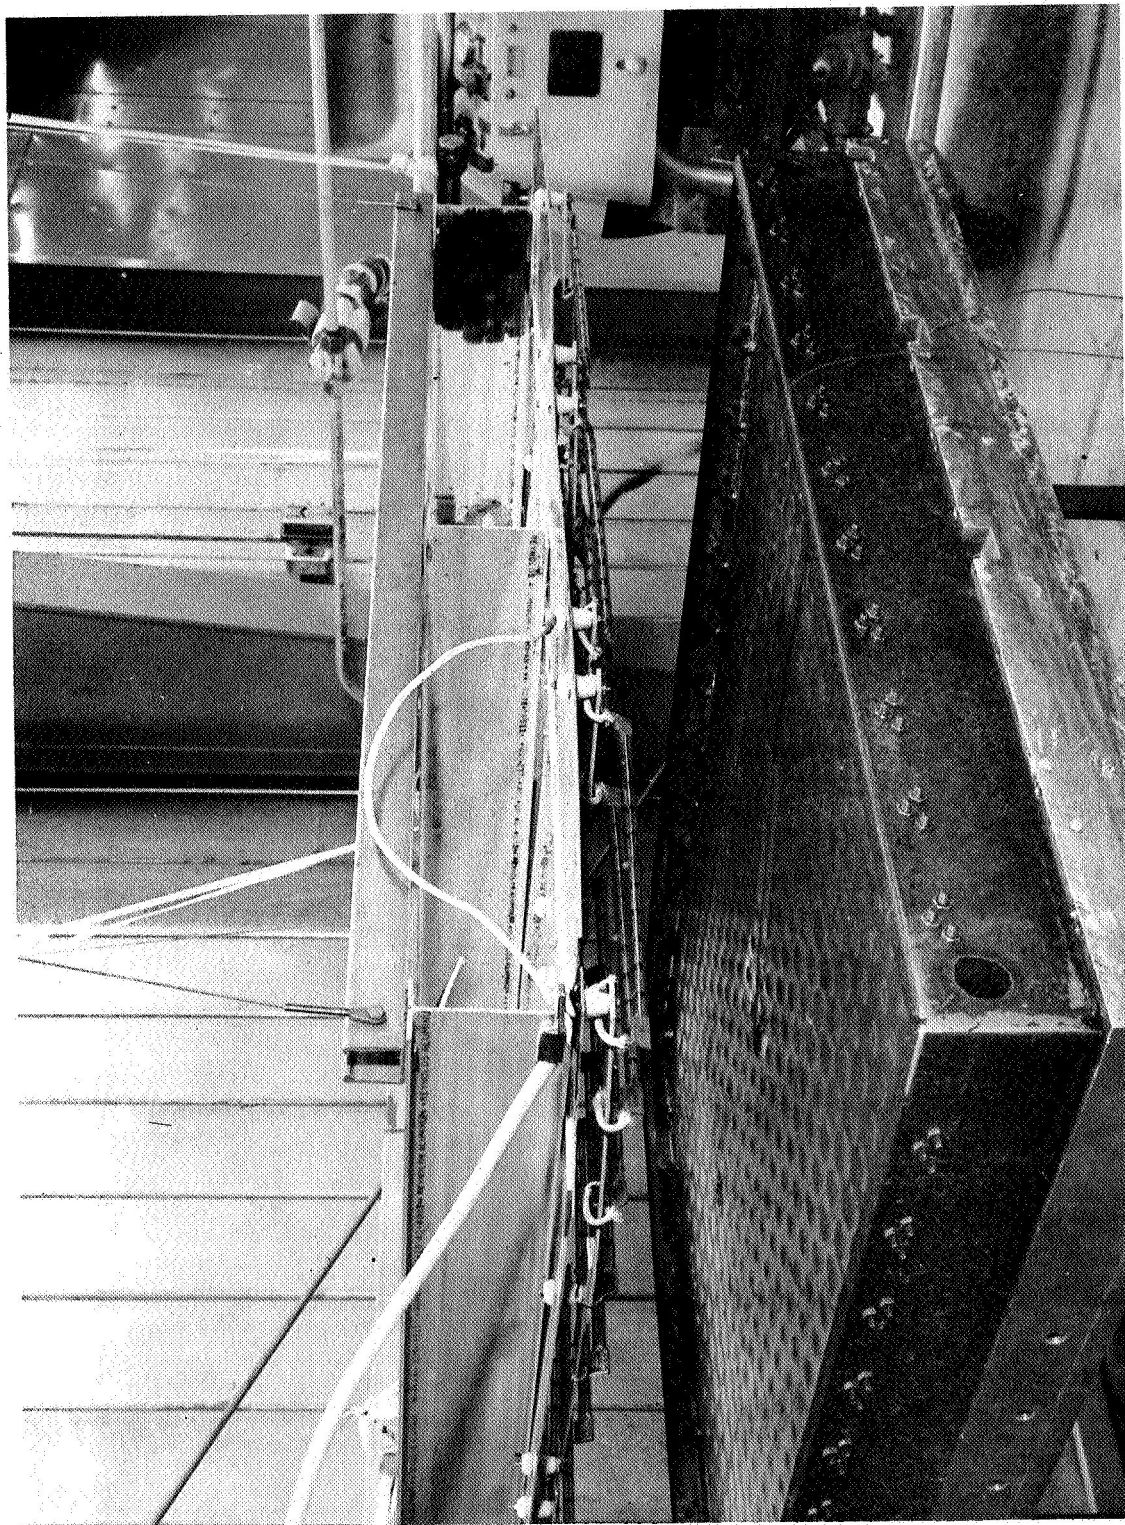
Figure 96.- Thermal Test, Radiant Heat, Mount Evaluation

Special design evaluation test.- Two special design evaluation tests were accomplished during the preliminary design evaluation testing. The first of these occurred before the mount evaluation testing of full-size detectors when it was thought

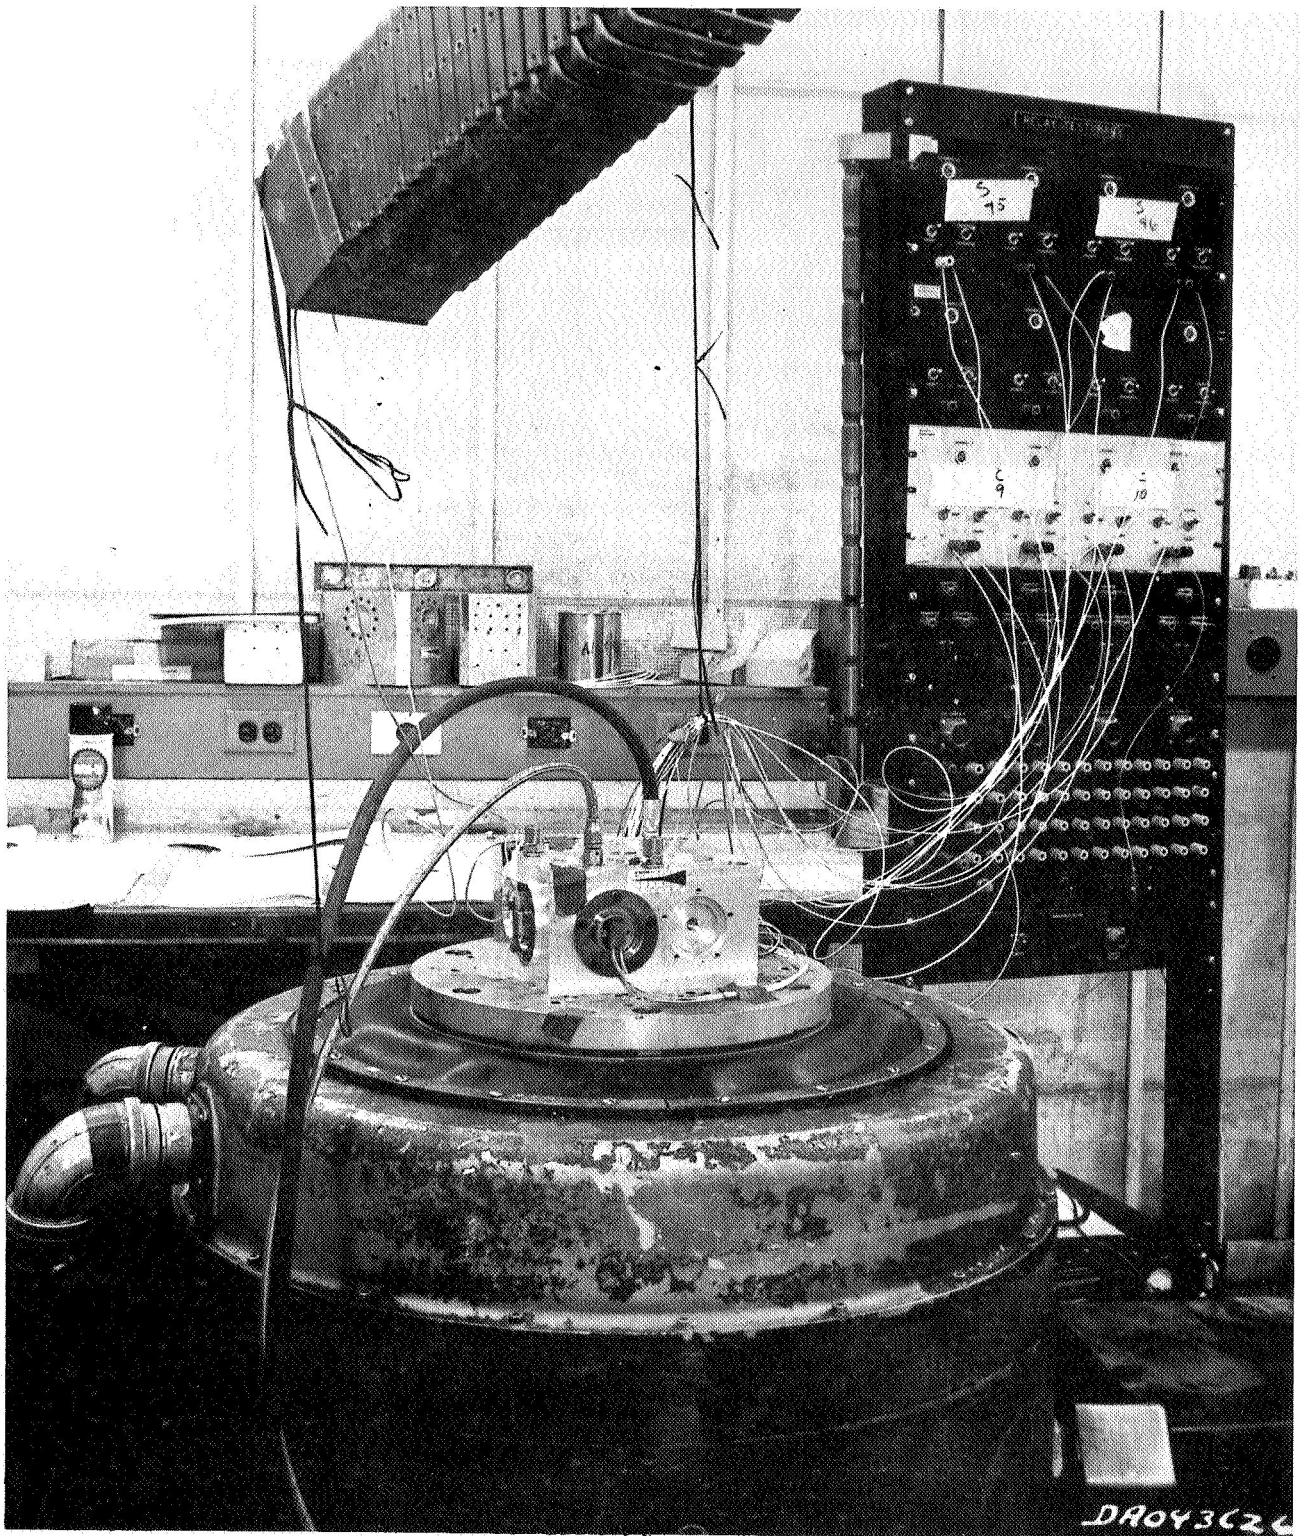
Figure 99.- Pressure Switch Vibration and Shock Test Setup

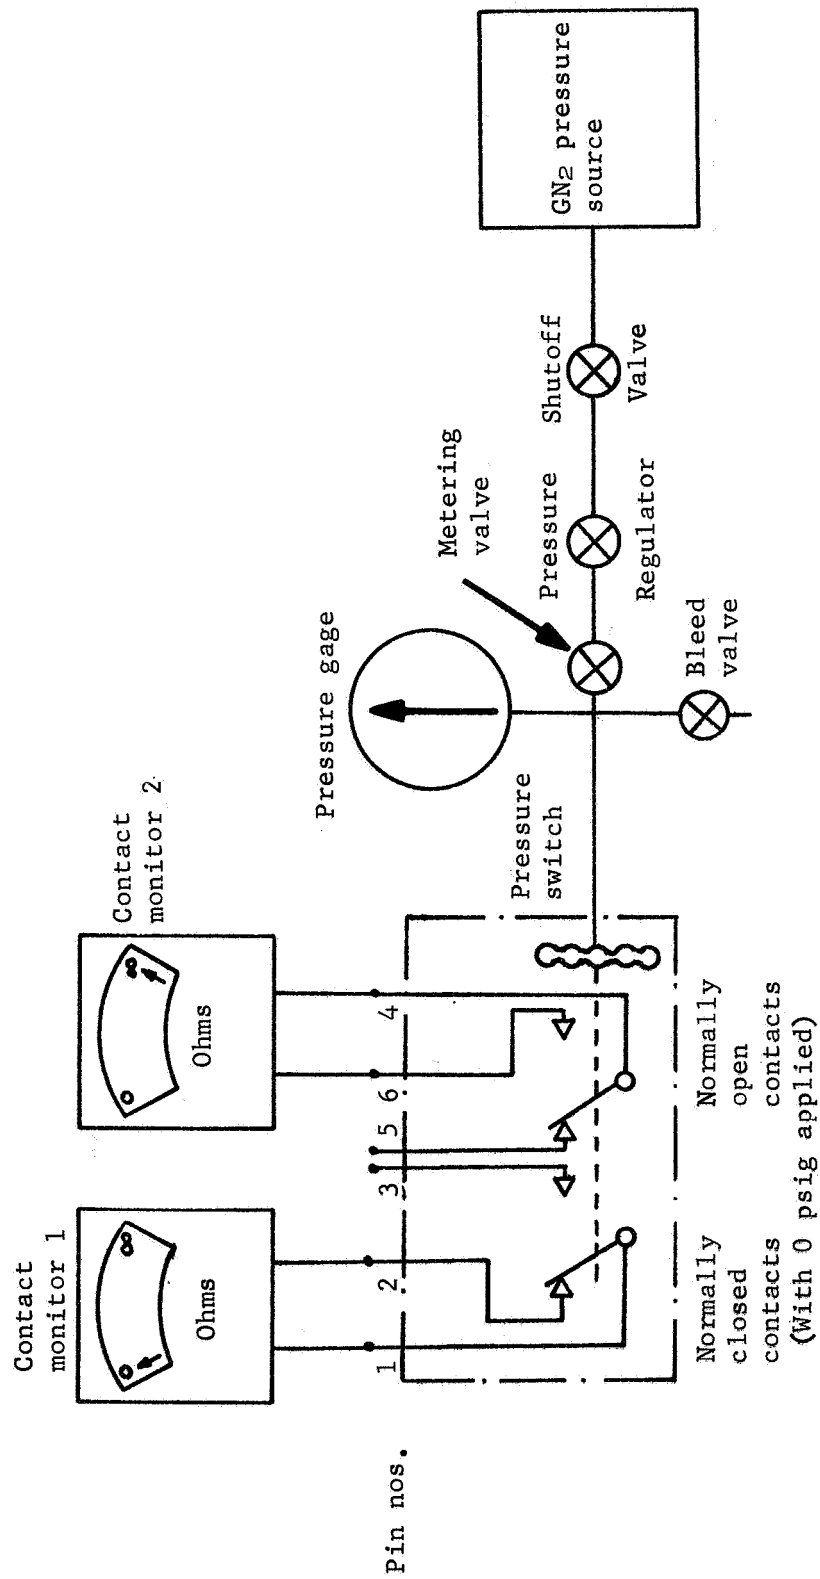
Figure 100.- Switch Monitoring Test Setup

Functional test: The specific test performed included both switch point verification and contact resistance testing. The test setup used is shown in figures 100 and 101. The test criteria for switch point test required that switch contact transfer would occur when applying a differential overpressure of  $6.0 \pm 2.5$  psig to the pressure port and verifying that the switch points reverse at the appropriate pressure levels. The contact resistance

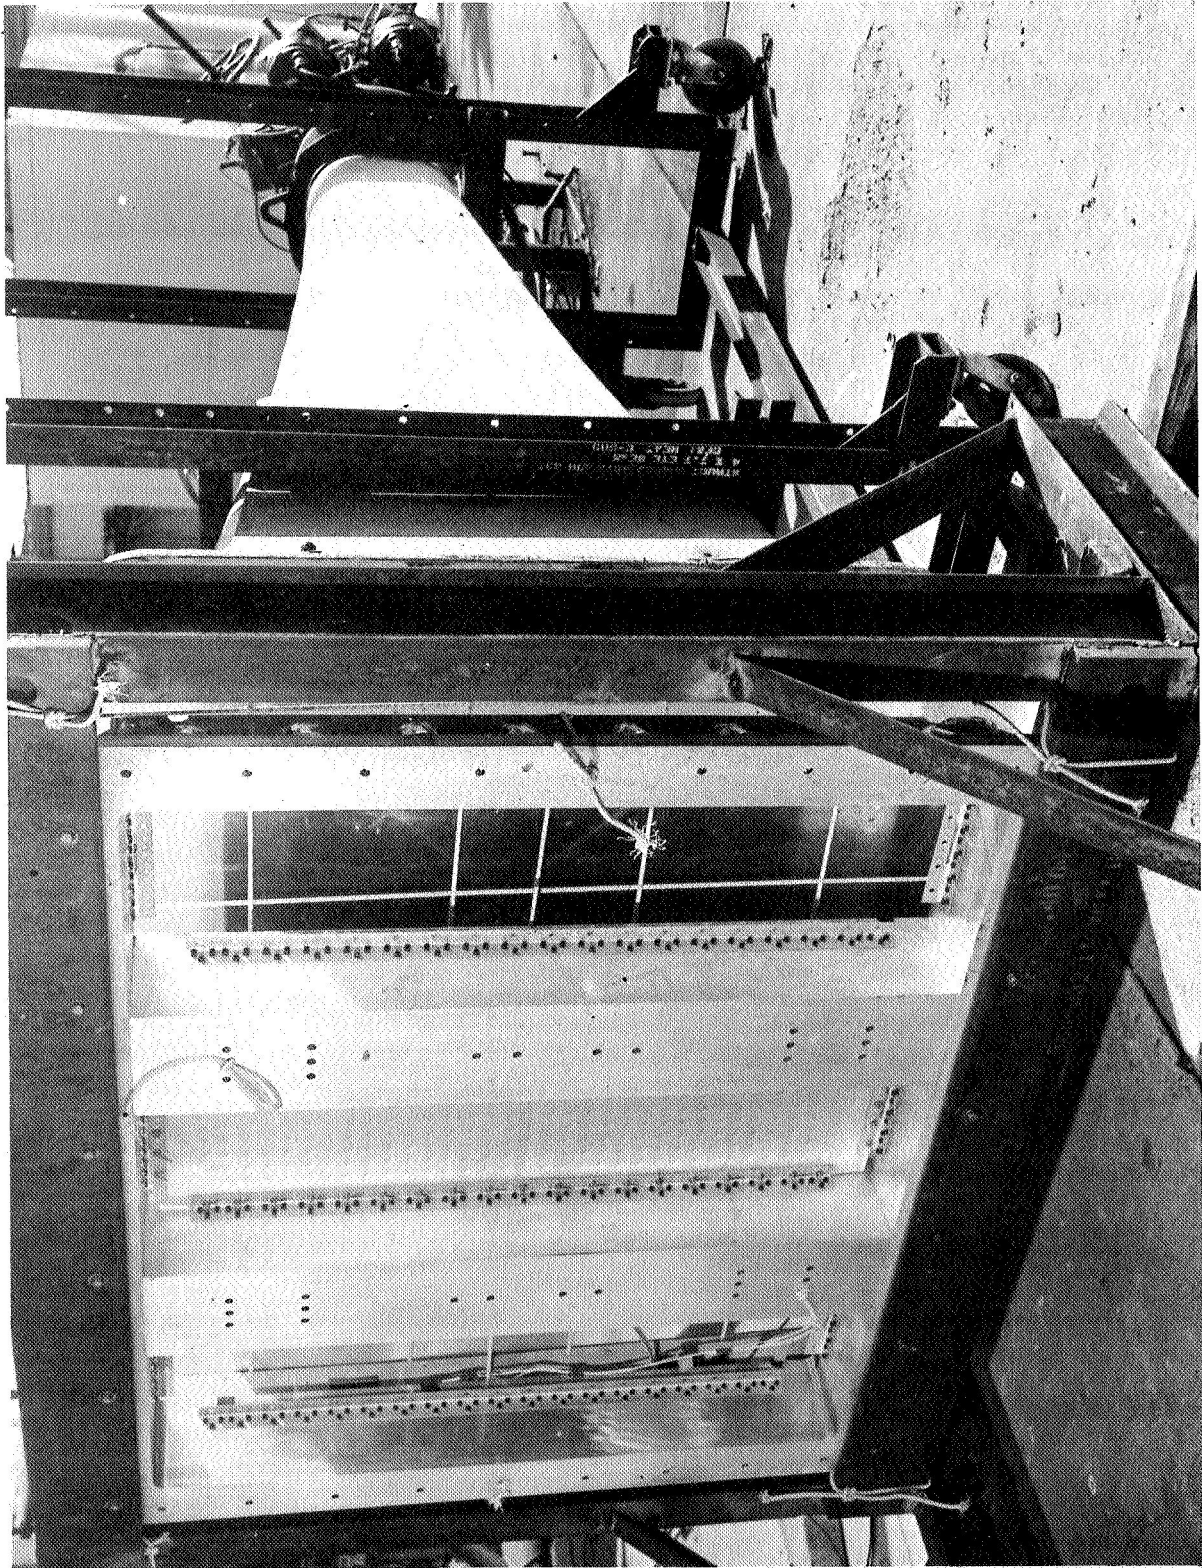
Figure 104.- Acoustic Test Setup, 40x12-in. Panel

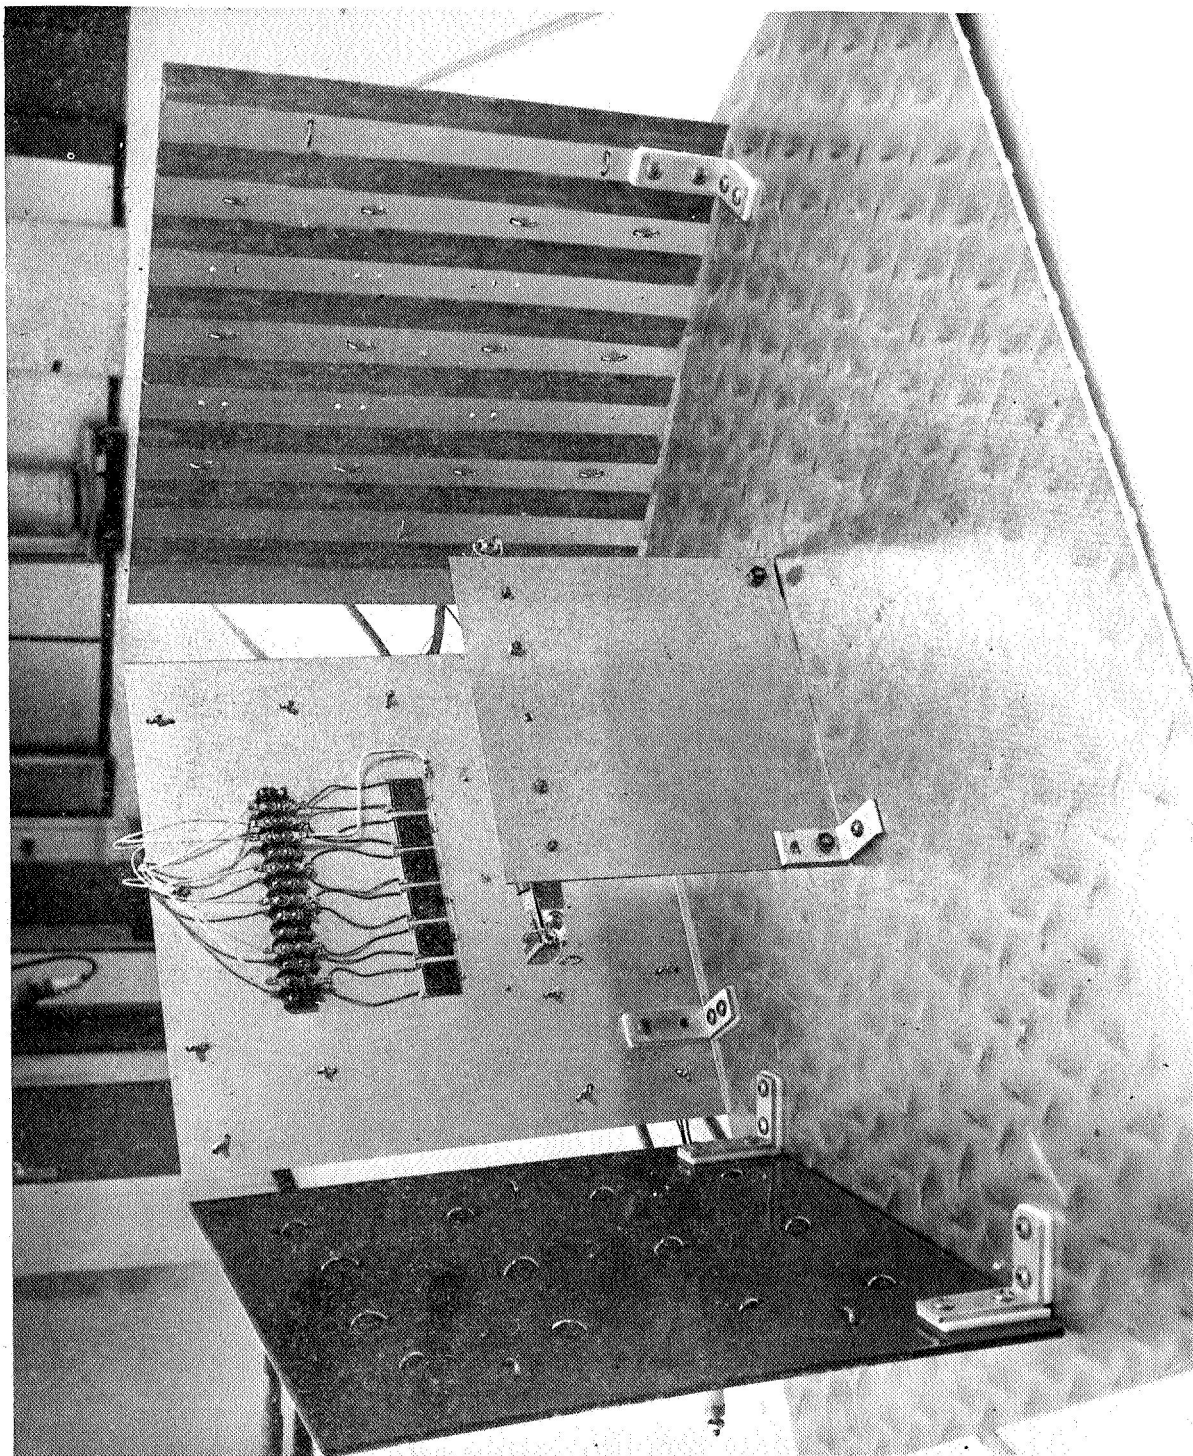
Figure 105.- Solar Cell Contamination Test Setup, Front View

The test setup is shown in figures 105 and 106. In general the fixture exposed six solar cells with an approximate area of

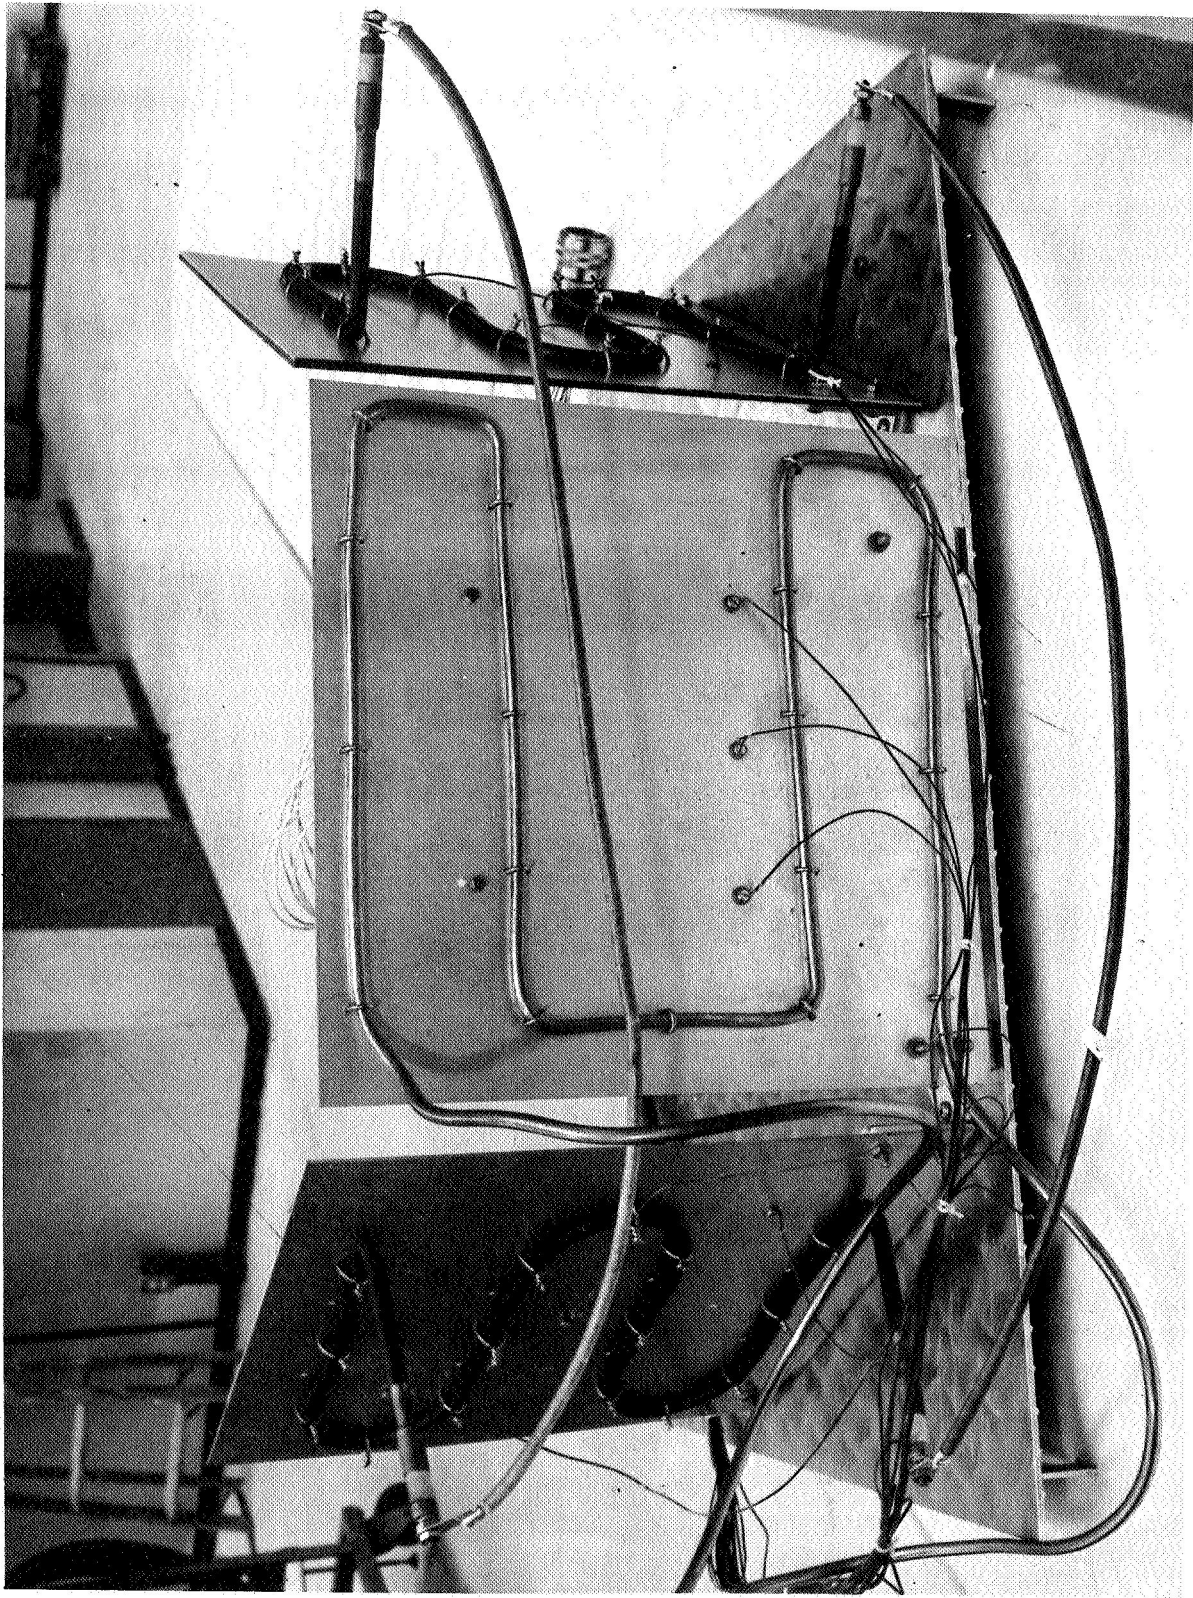
Figure 106.- Solar Cell Contamination Test Setup, Back View

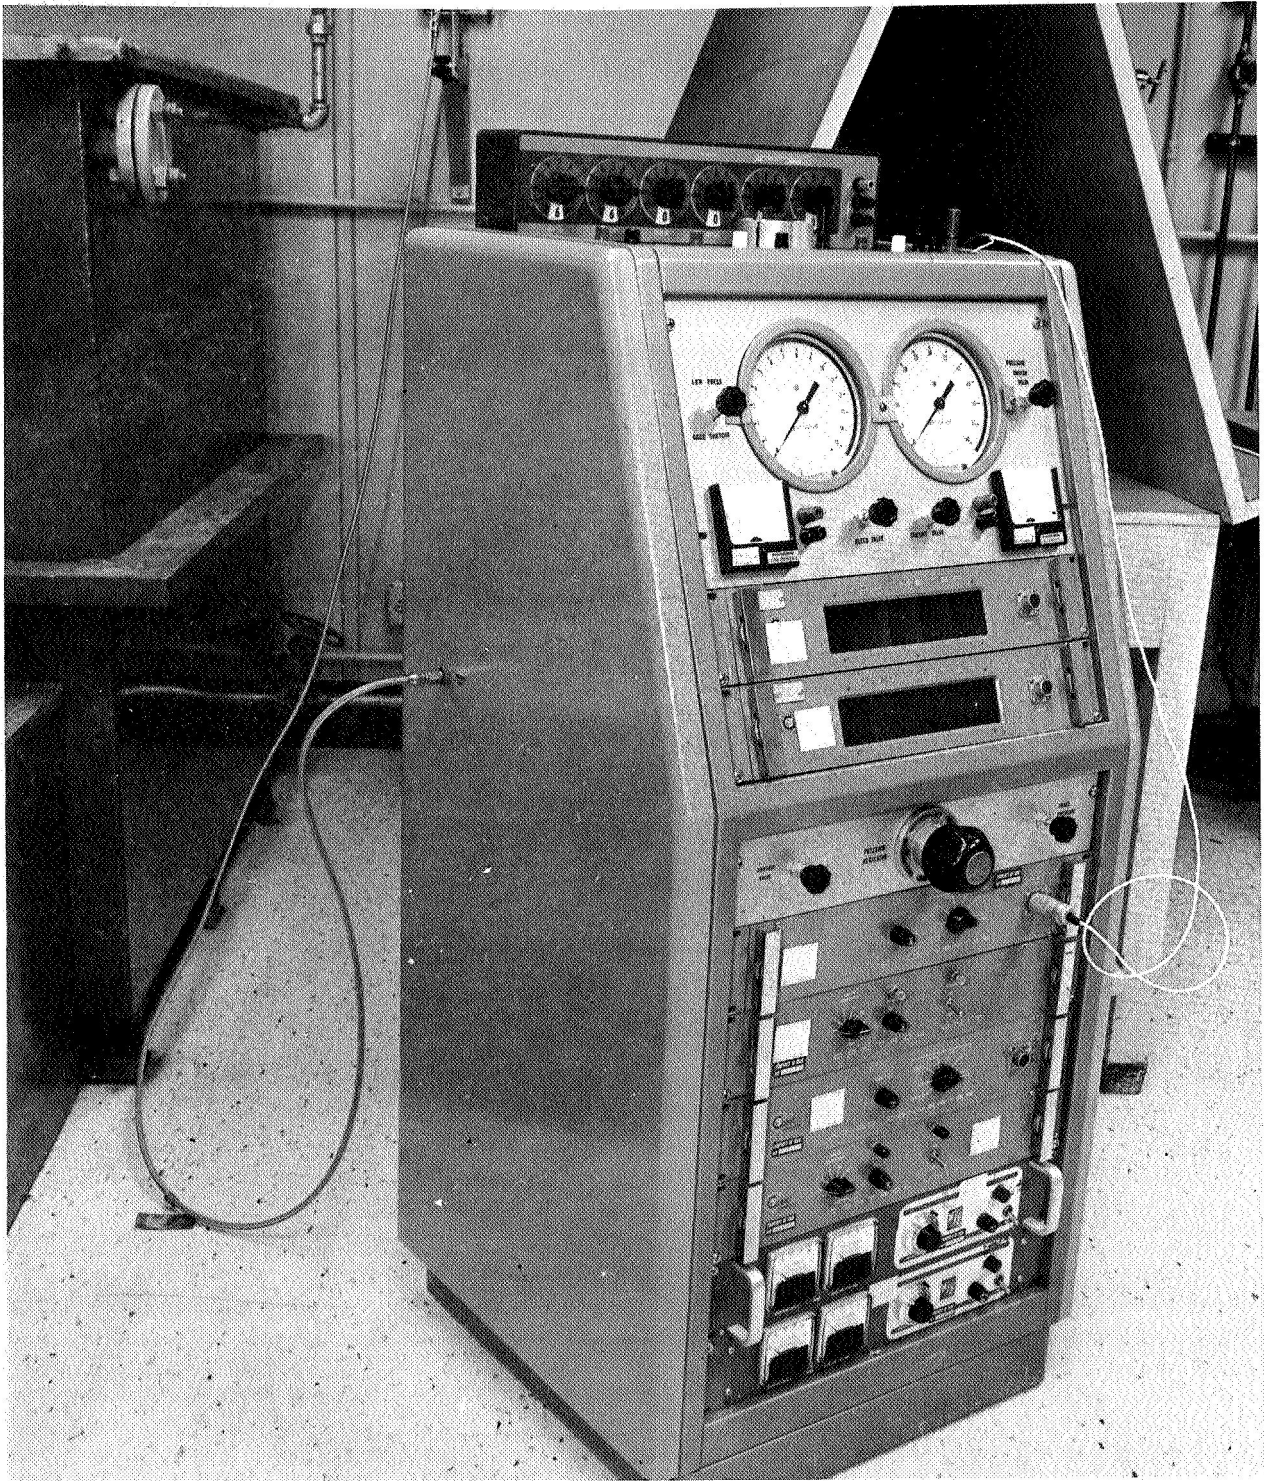
Figure 107.- Functional Test Tool for Pressure Switches and Panel/Detector

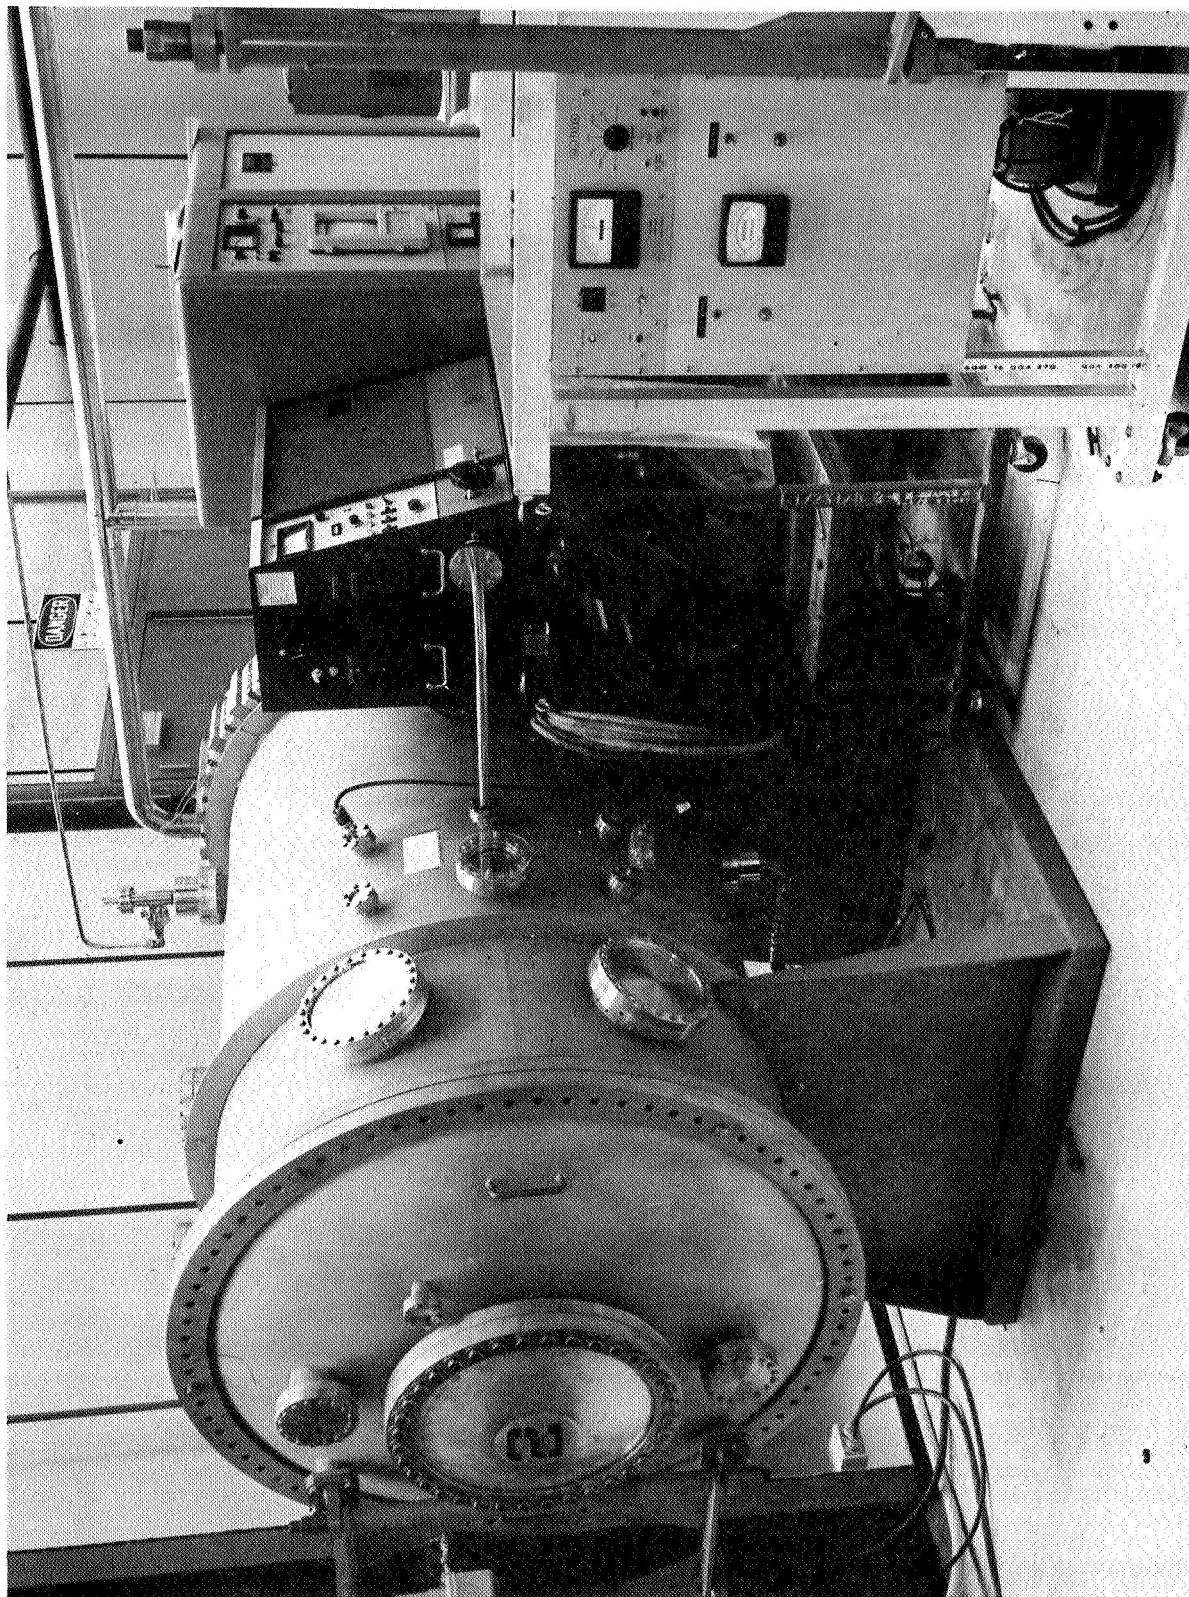
Figure 108.- Helium Leak Test Setup

For the helium leak test each specimen was placed in a vacuum chamber (see figs. 108 and 127) in which the pressure was reduced to  $1 \times 10^{-5}$  torr, or less, pressurized to  $27.4 \pm 0.5$  psia, and leakage sensed at the normally exposed surface of the specimen. The maximum allowable leak rate was determined by the test specimen volume (see RGA leak). The test was conducted after proof pressure, after dynamics, and after thermal cycling on the D3A, E1A, E3A, and F1A specimens. For the B1A, C1, and D2A specimens, the test was conducted after dynamics and after thermal cycling. The initial leak test for the B1A, C1, and D2A items was an RGA leak test (see below).

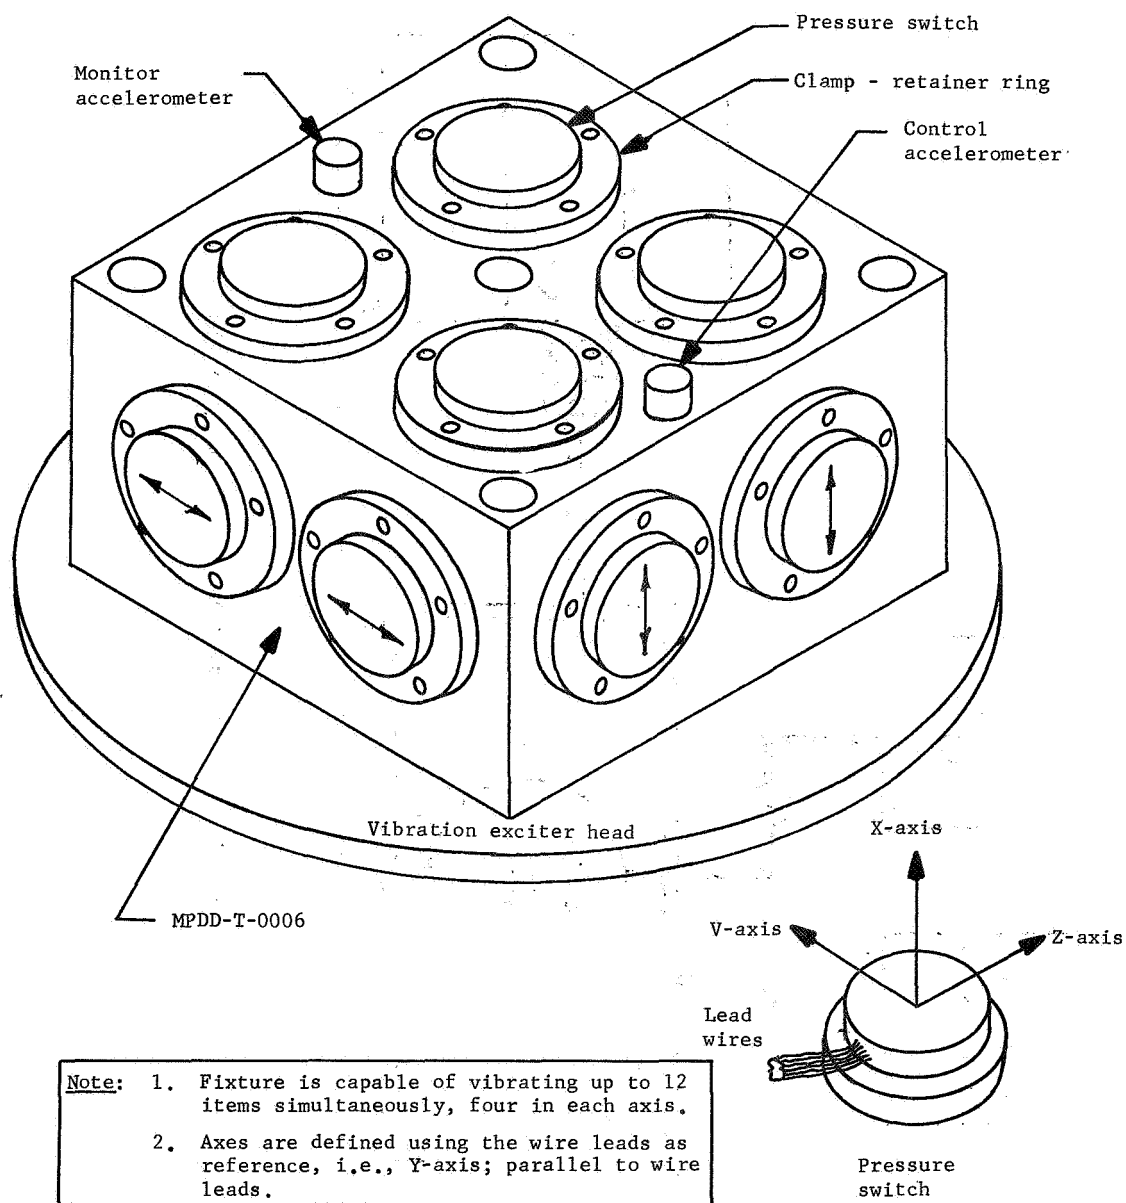
Figure 110.- Vibration Test Setup Sketch

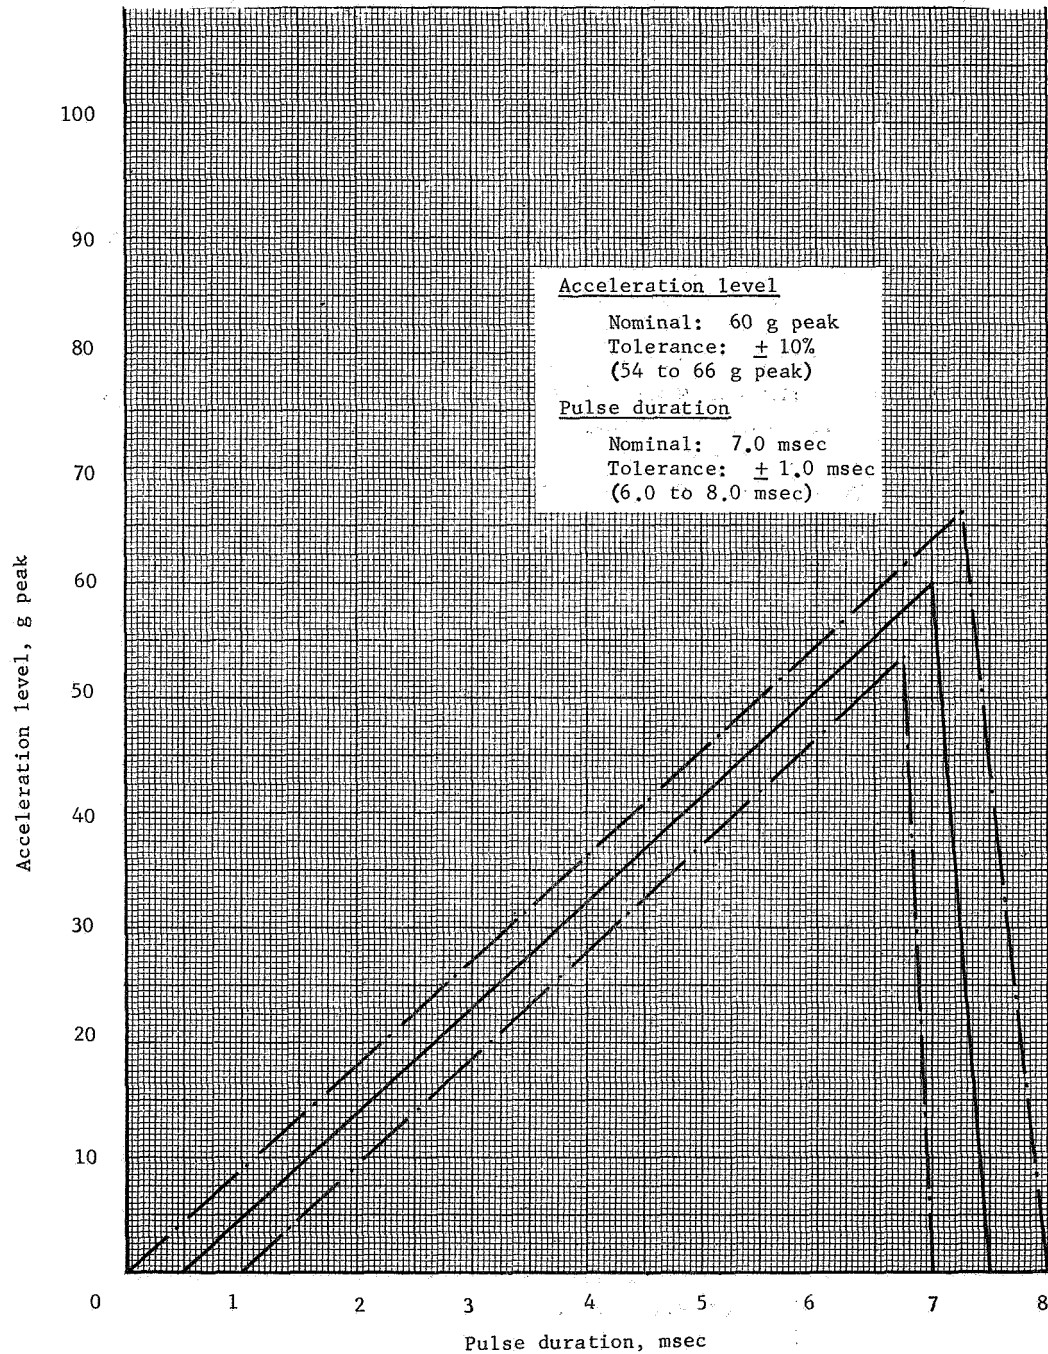
Figure 113.- Sawtooth Shock Pulse Specification. Pressure Switch FAT

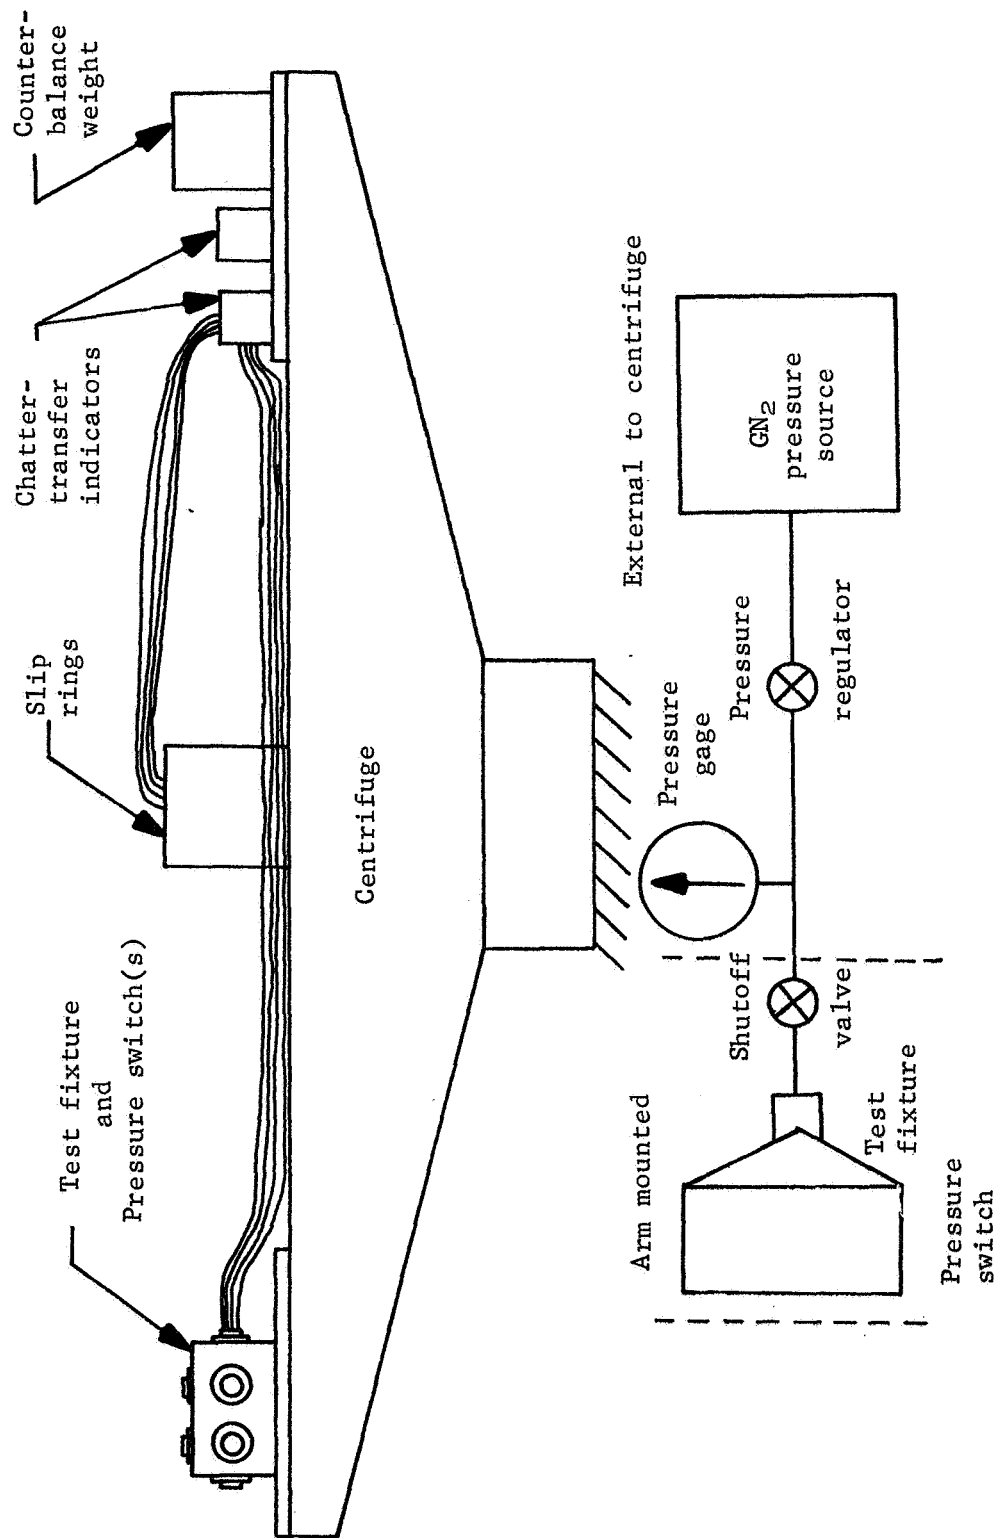
Figure 115.- Sustained Acceleration Test Setup Sketch

A sustained acceleration test was performed on qualification test specimens. The test consisted of 6 g in each of 3 mutually perpendicular axes for a duration of 3 minutes/axis. During the test, switch contacts were monitored for transfer, with the specimen pressurized to  $27.4 \pm 0.5$  psia. The test setup is depicted in figure 115 and shown in figure 116.
